EARTHEN HERITAGE DIAGNOSIS

French Embassy in Ghana | FSPI Sankofa

Sebastien Moriset, CRAterre | December 2021

CRAterre project code GHA031

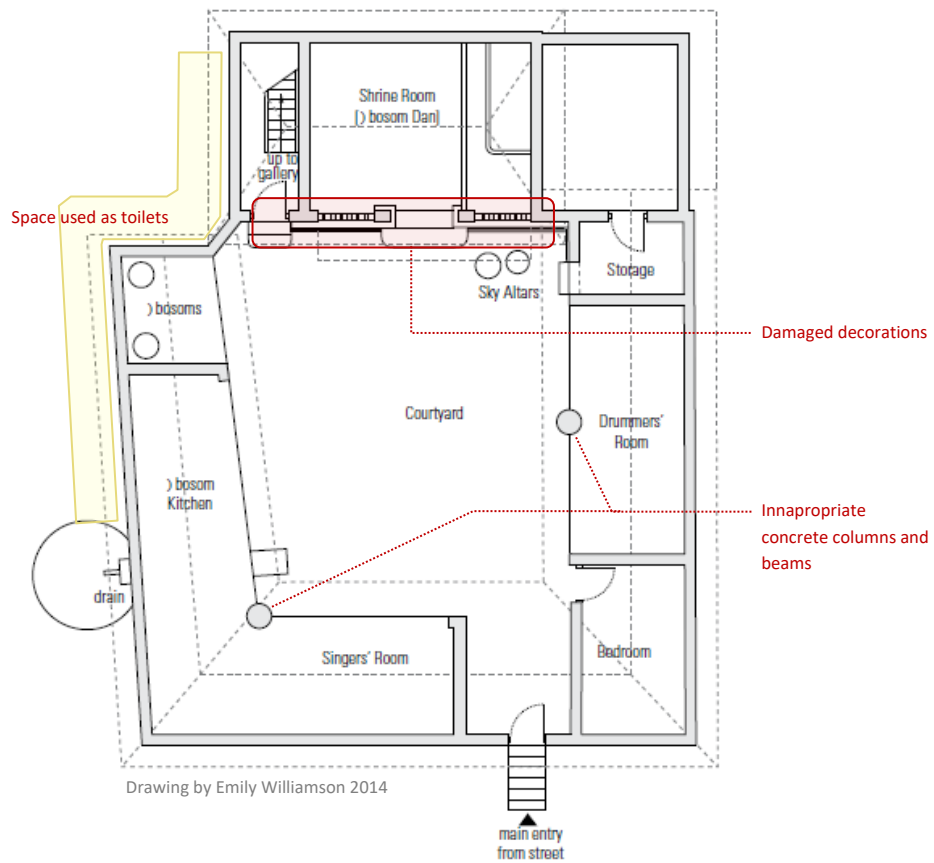
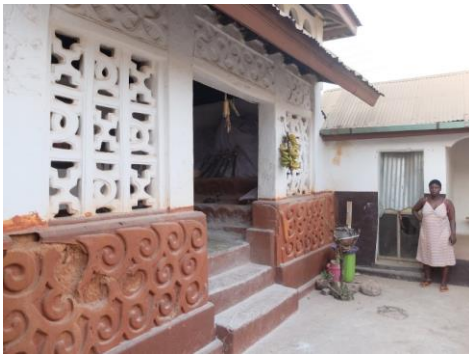
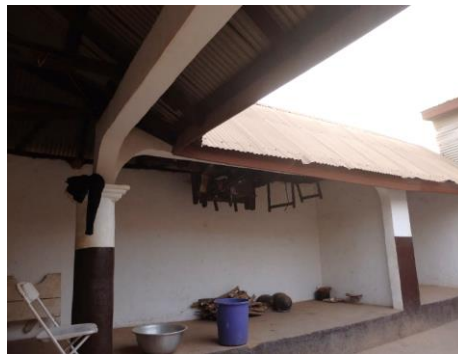
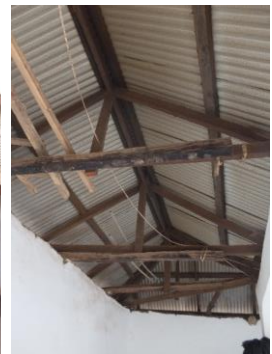
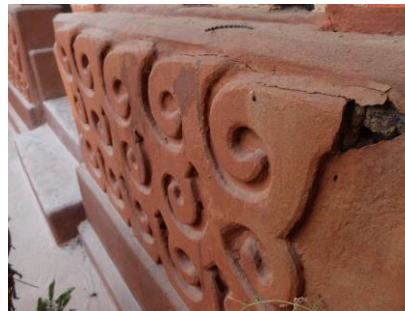
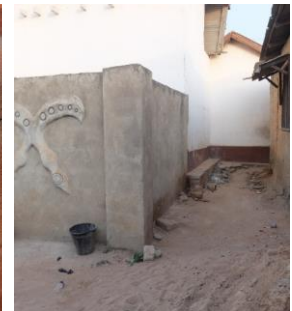
The place is very clean. Only a few decorations need some minor repairs. The perimeter drainage is perfect, as is the roof. A few wooden purlins will have to be changed in one or two years.

Examples of damaged decorations

Fixing the decorations. 2 days of work.

On the long term (after fixing more urgent problems on the other shrines), the concrete pillars in the courtyard could be replaced or hidden within thicker mud pillars. The concrete lintel could also be covered with traditional decorations.

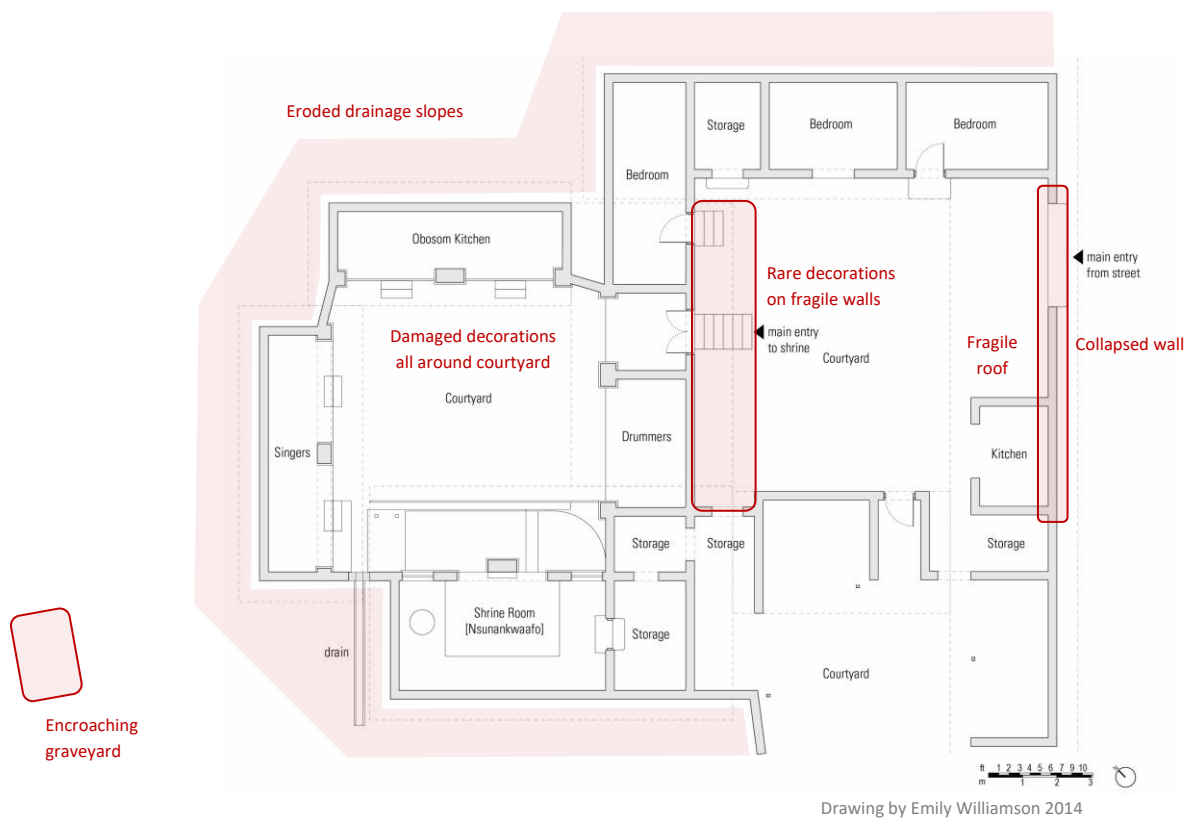
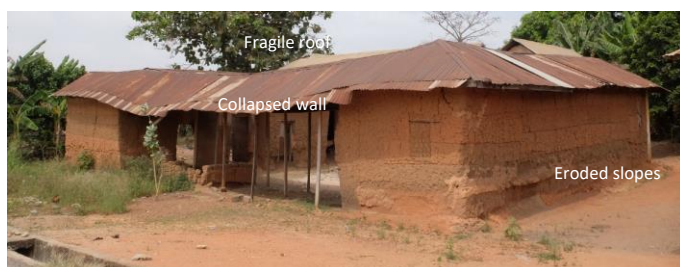
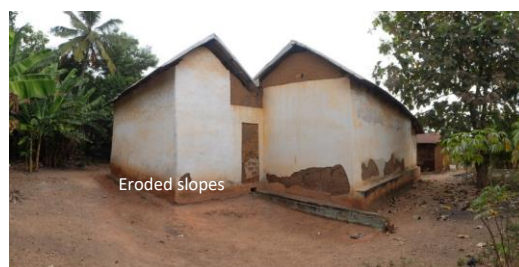
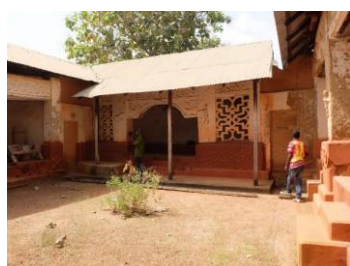
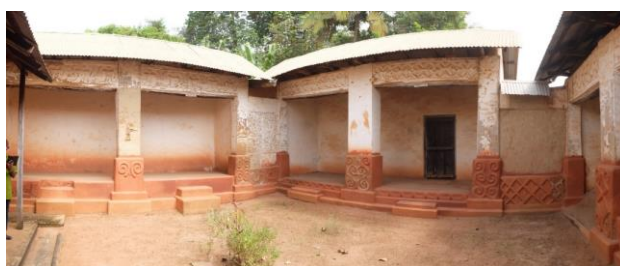
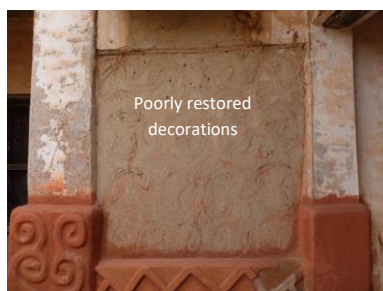
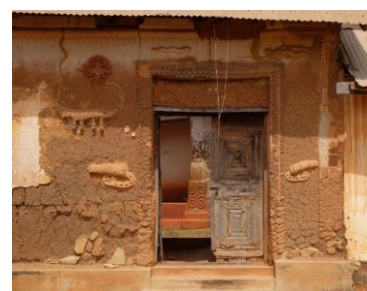
2.3. Adarko Jachie

Although the site is relatively clean, it is in an advanced state of disrepair, especially the house on the road side. The drainage that was done in 2014 is badly eroded on the periphery due to the increasingly heavy rains that wash everything away. These rains have also damaged many of the decorations inside. Decorated surfaces had also been poorly restored and it is noticeable. The first courtyard near the street still has some very beautiful decorations on very fragile walls that have been badly eroded at their base.

Very fragile roof, eroded drainage slopes, eroded wall bases and damaged decorations

- Drainage of the surrounding (9 trips of laterite required). The most exposed surfaces receiving the roof dripping can be stabilised with cement. The sections receiving all the water under the edges of the roofs can be stabilised. The last few centimetres on the surface should be made with soil stabilised with 5% of cement. This was done at Besease and it proved to be resistant to erosion.
- Reconstruction of the front wall (1 trip of laterite)
- Consolidation of the roofs and extension of the eaves (1 foot) above the exposed decorations
- Restoration of decorations (1 month of work)
- Sensitization of the community

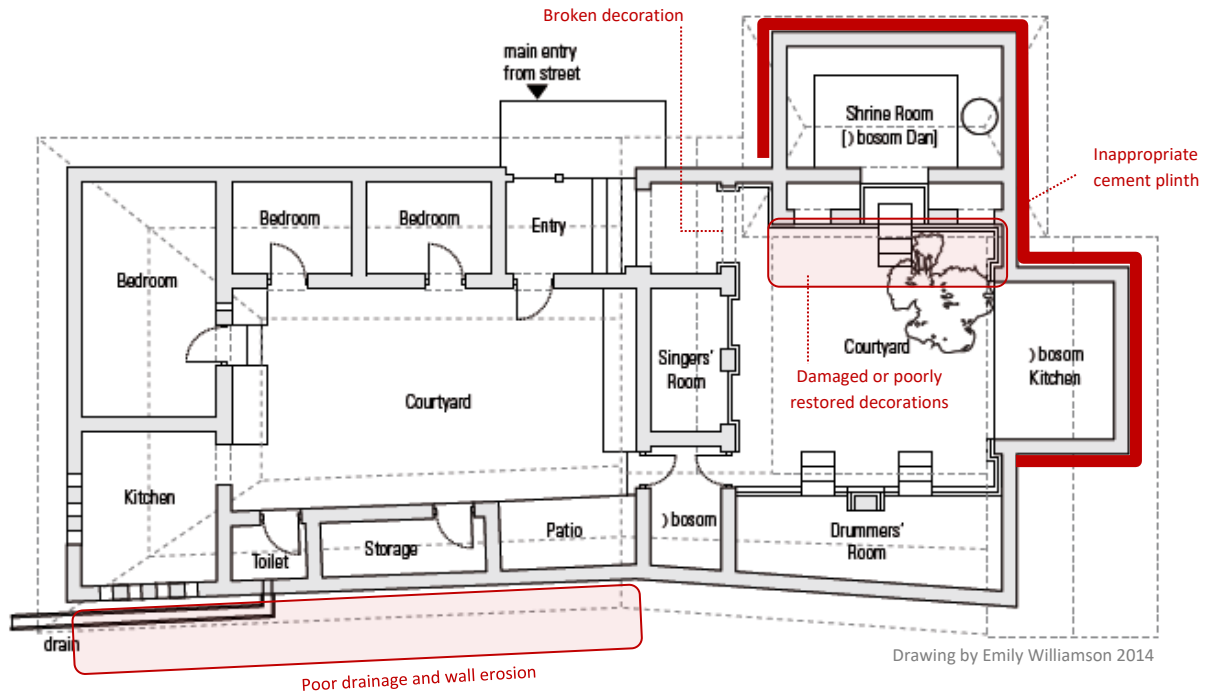
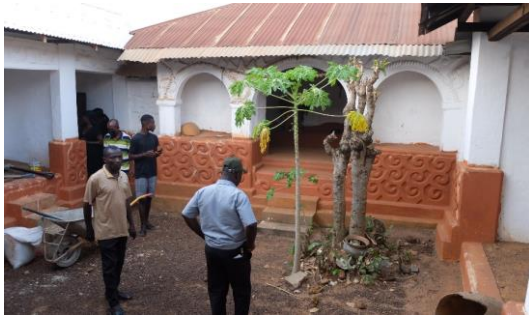
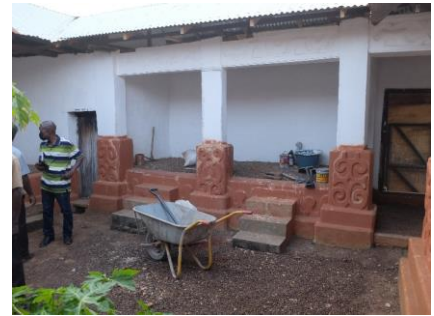
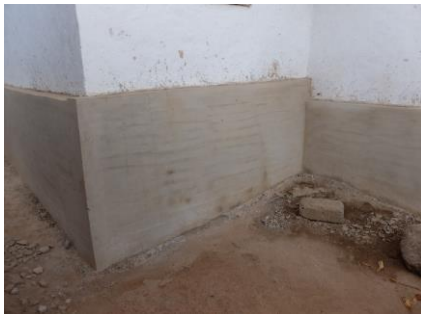
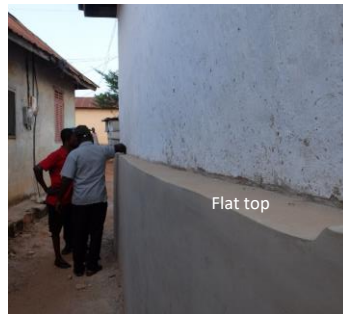
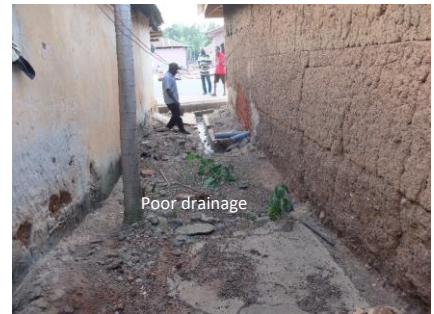
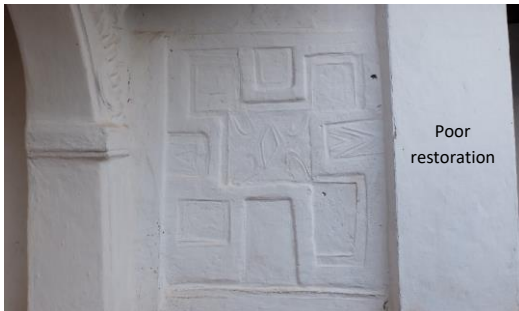
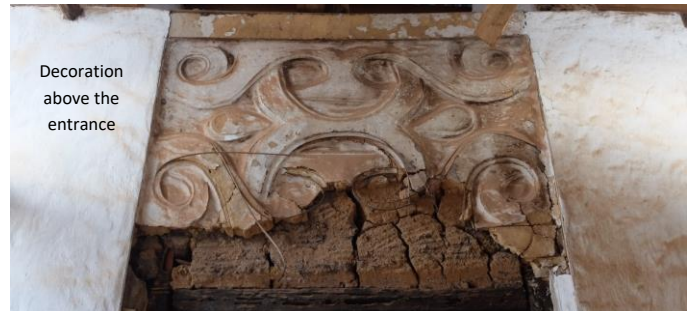
2.4. Asawase

This property is currently being partially renovated by craftsmen supervised by GMMB. They are replacing the roofs. The shrine is generally well maintained and in good condition. The base of the walls have been re-plastered, unfortunately with a thick sand-cement coating which may bring humidity problems in the future. the top of this plinth is also a problem as it is horizontal and water will stagnate on the flat surface and erode the walls.

Many of the decorations have been badly restored and lack depth. The decoration above the entrance is seriously damaged but was already broken in 2014.

Partially restored roof, inappropriate cement plinth, poor drainage on the southern side badly restored decorations and broken decoration above the entrance.

- Improvement of the drainage on the Southern side
- Reinforcement of the wall base on the southern side
- Revision of the shape on top of the recently added external plinth (North and East sides) to avoid water stagnation on top of the plinth
- Restoration of the wall decorations (damaged ones and poorly restored ones)

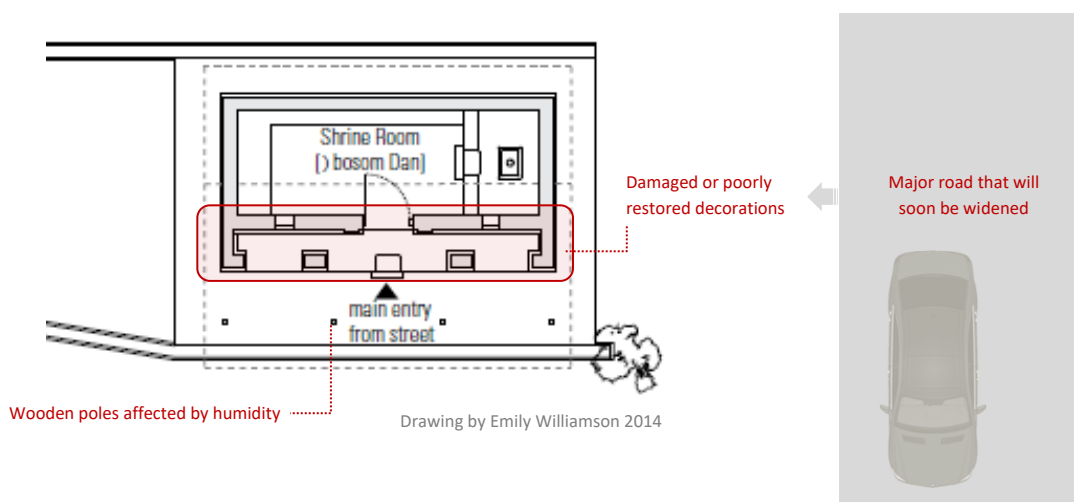
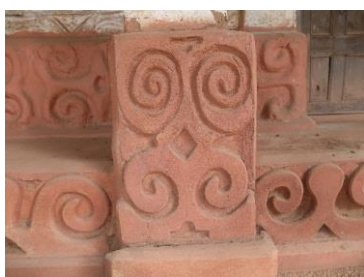
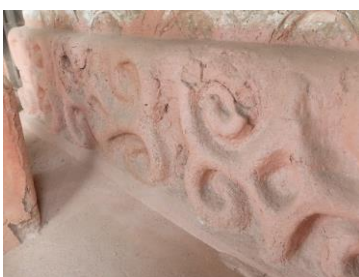
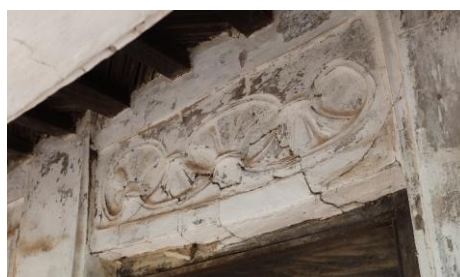
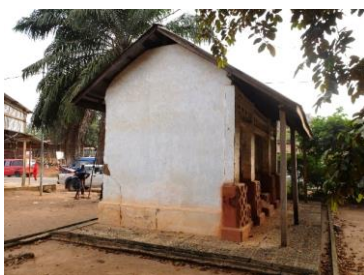
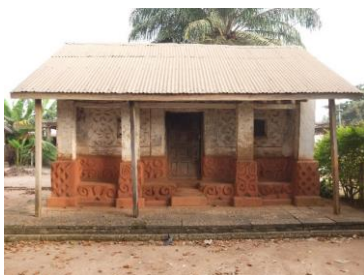
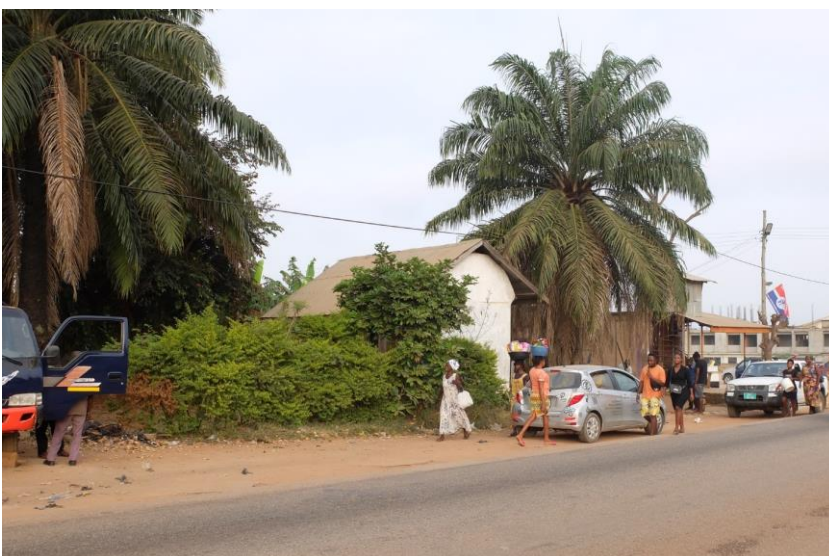
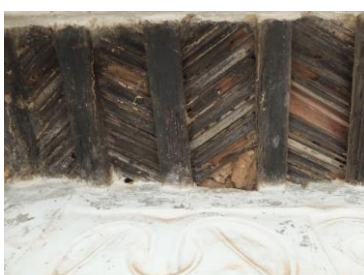
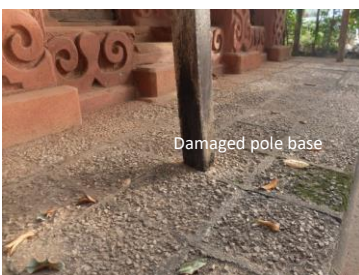
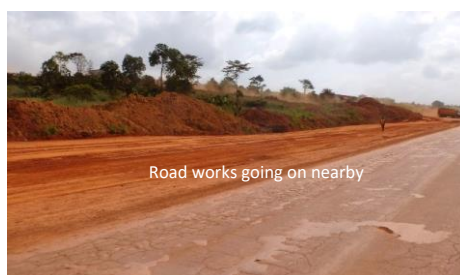
2.5. Asenemanso

The roof is in good condition and the site drainage works well. The wooden poles holding the roof start to deteriorate at the base. Many decorations are either damaged or poorly restored.

Dangerous proximity to the road, damaged wood and decorations in poor condition because of poor restoration or direct erosion

- Sign agreement with Ghana Highway Authority to make sure road works will not affect the site
- Restoration of the damaged and poorly done decorations (3 days of work)
- Replacement of the wooden poles in front
- Treatment of the ceiling, doors and shutters with insecticide

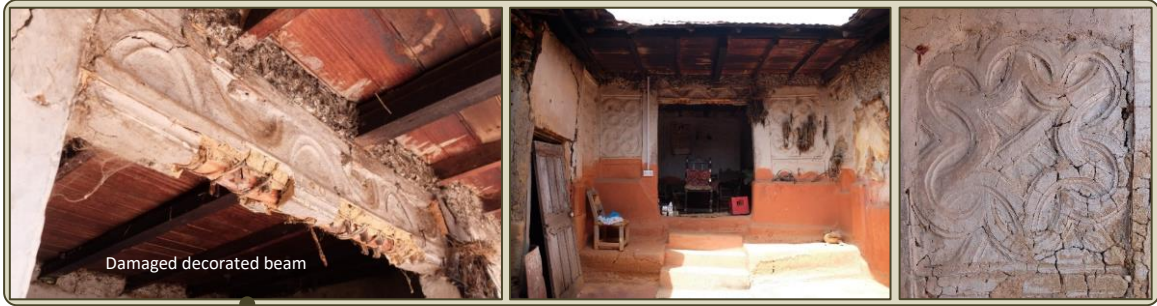
The very authentic Chief Palace, well preserved although many decorations, pillars and beams require slight repairs

- Work on the decorations (4 days work by highly skilled and experienced conservator) to avoid falsifying this unique testimony

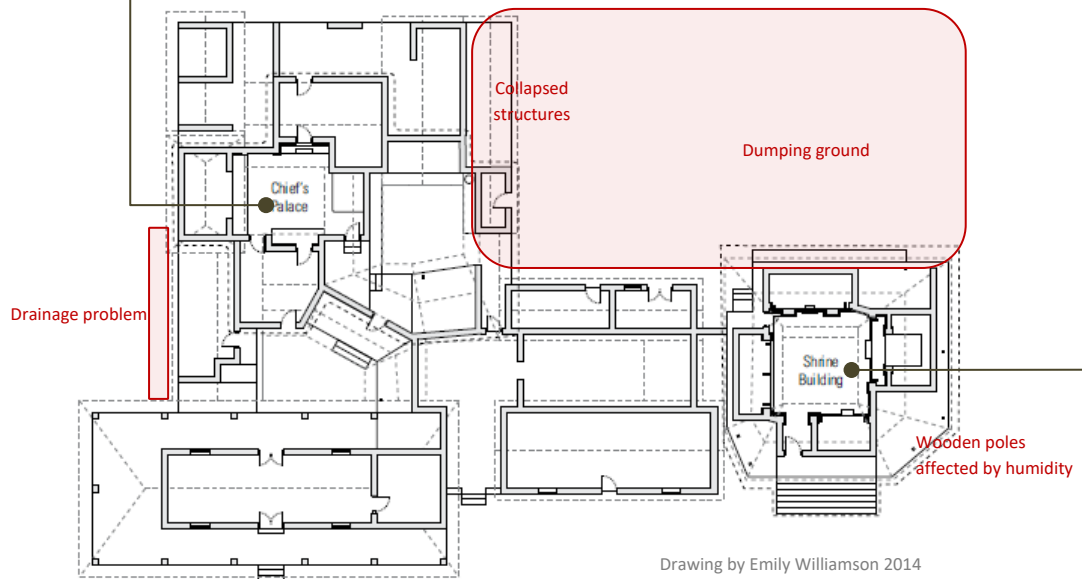
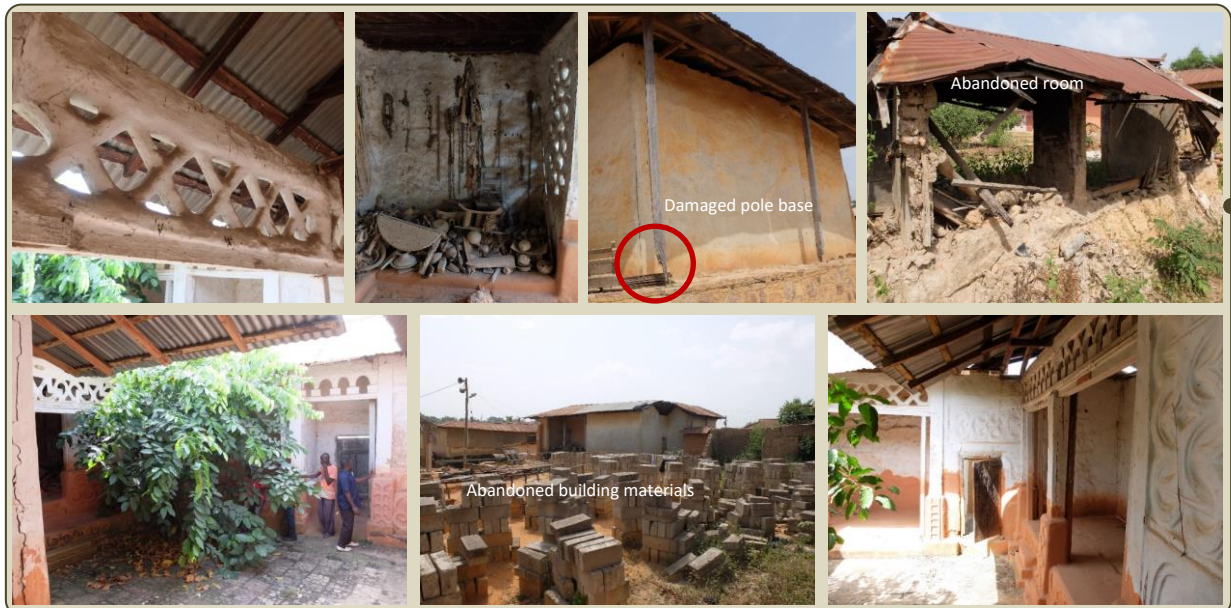
The roofs of the shrine are in bad condition, which damages some elements of the walls, decorations and wooden elements. Traces of stagnation on the ground show that the roofs are not playing their role. Without the roofs being restored, the damage could accelerate. The fetish tree is impacting the walls and could contribute to causing damage in strong winds. In the Chief palace, the roofs are also defective in places, but their large overhang has protected the walls relatively well. However, a lot of spot damage can be seen on the walls, pillars and decorated surfaces.

Abandoned shrine building and untidy environment

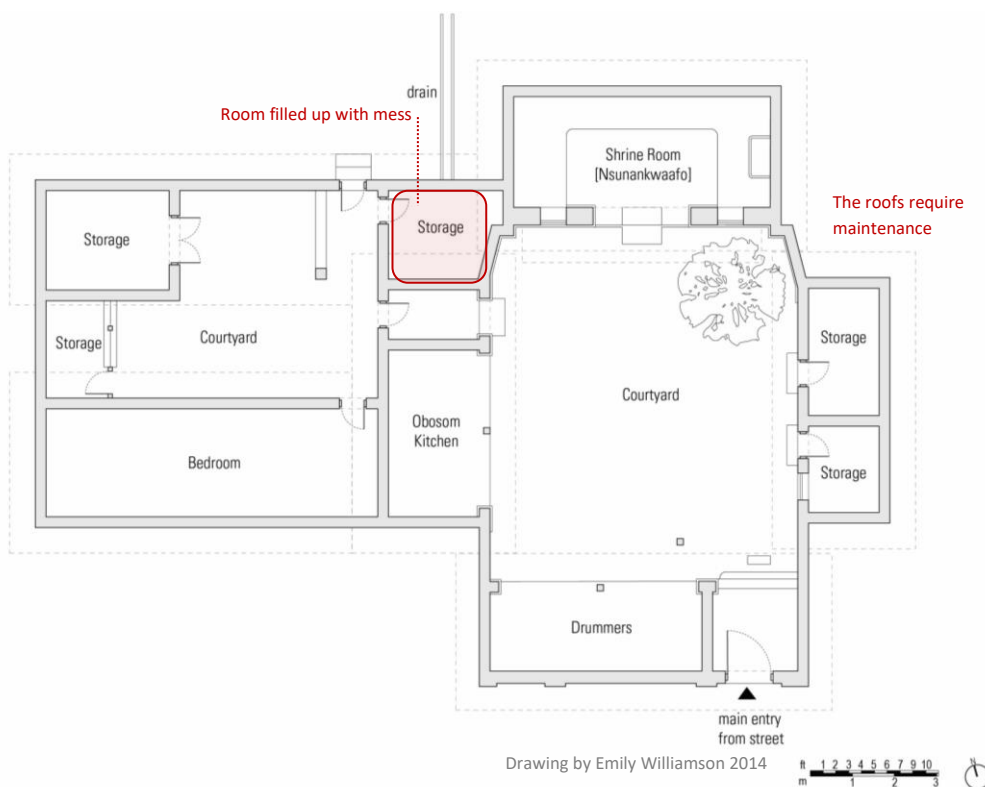
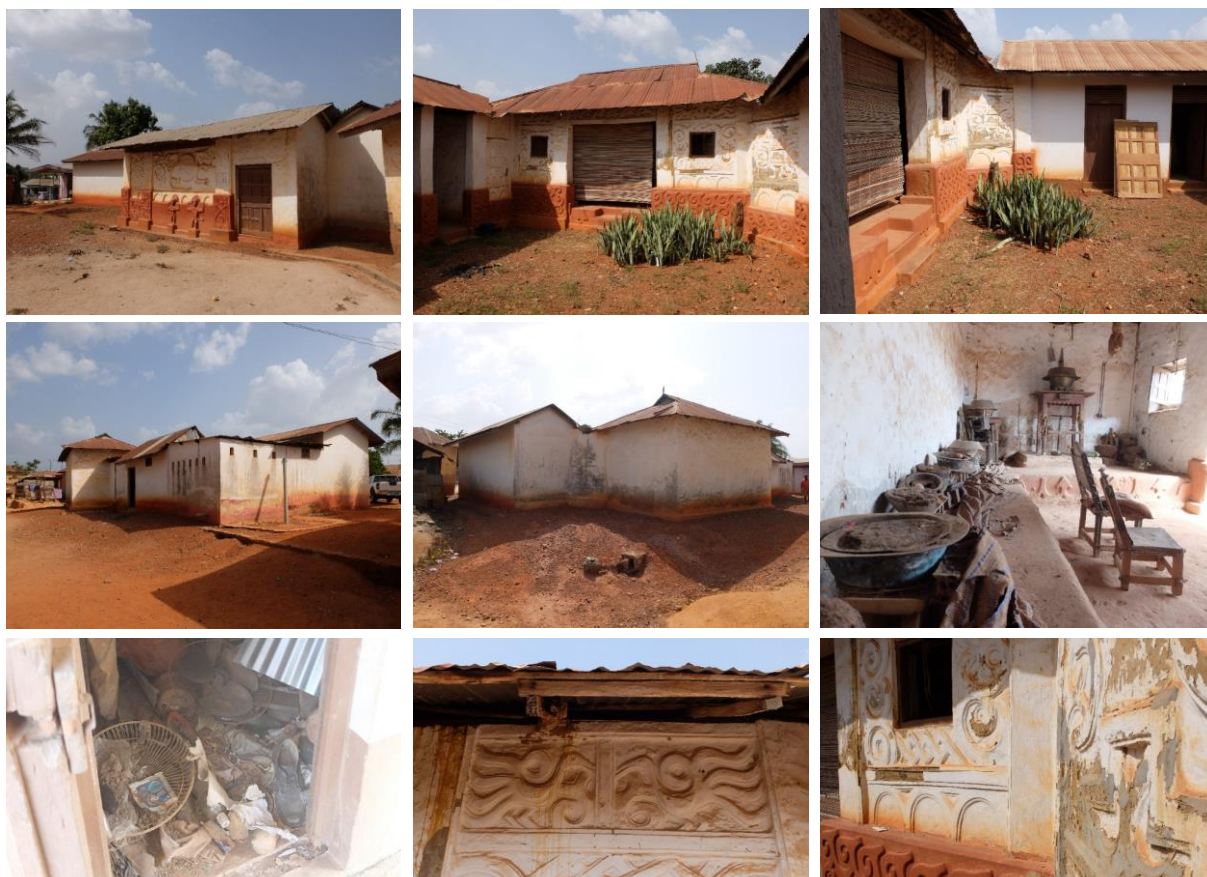
2.7. Edwenase

The property is relatively clean and well preserved but small deteriorations are visible on the walls. The roof has reached the end of its life. It is leaking in several places and many of the decorated surfaces have suffered direct erosion because of these leaks.

This site is generally clean except one room at the back. The shrine room remains very impressive with its movable heritage in place. The roof is leaking. Many decorations have suffered erosion and need to be restored

- Fixing the roof
- Emptying the room at the back to avoid attracting termites
- Restoring the damaged decorated walls (6 days of work)
- Remove the stones from the courtyard

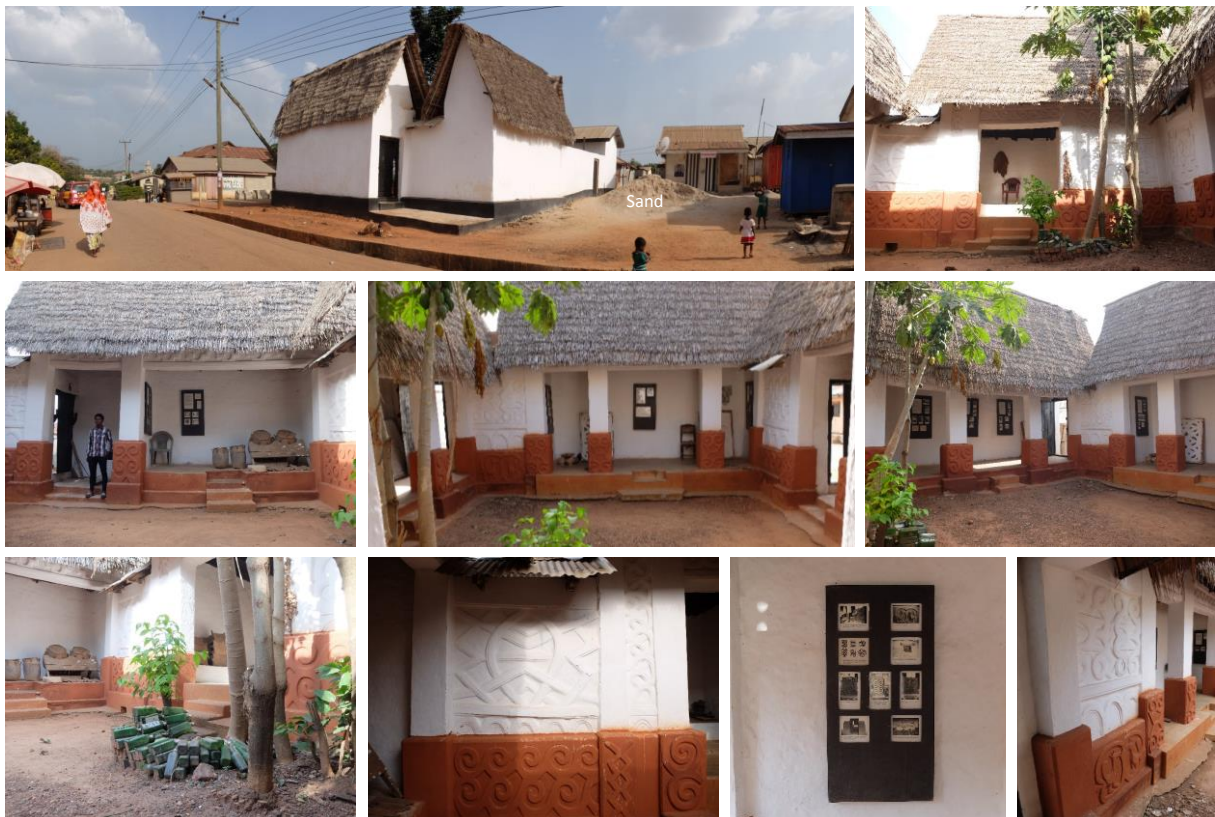
2.8. Ejisu Besease

The state of conservation is very good. The only problems noted are the accumulation of material on the exterior, along the north and south walls of the property. This is easily reversible. The ground is also eroded in the north-west corner and would benefit from being raised slightly to prevent further gullyng.

A well-preserved shrine which is only lacking a priest(ess) to be fully alive

- Marking the site boundaries with a visually non-intrusive fence (shrubs fence for example) to avoid encroachment
- Discuss with the community to ensure that no encroachment will take place.
- Work with the town planning authorities to ensure that no storey building will be allowed in a 500 m radius.

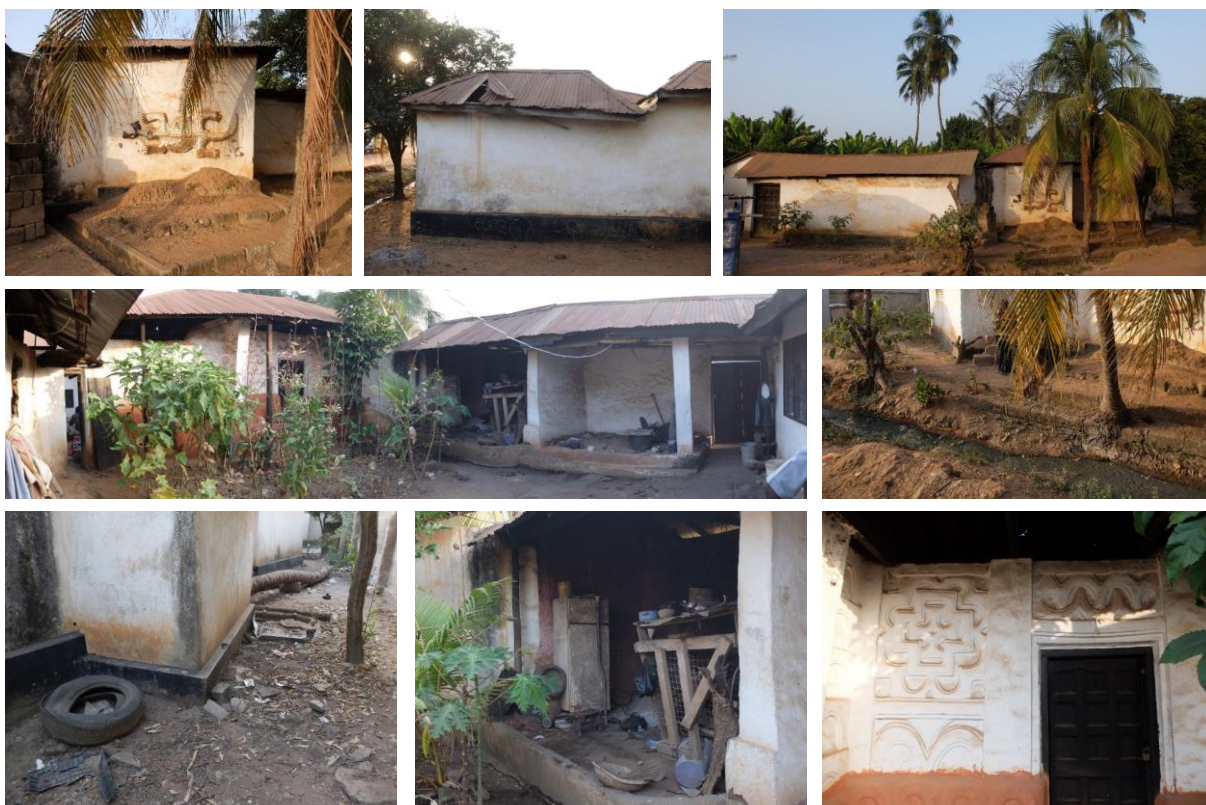
2.9. Kentinkrono

The crocodile decoration on the outside wall is damaged. The other decorations inside are still in good shape. Cement blocks have been stored against the outside walls. All the roofs are in very poor condition with major holes on the eastern side. Despite the widespread dirt, the walls still look sound at the moment. Drainage slopes could not be assessed as all floors are clogged. In any case, the omnipresence of vegetation is not reassuring.

This beautiful property is currently a real shame.
It is not even cleaned and dirt piles up inside and around the buildings. This is a pity.

- Find a proper caretaker and remove the person squatting the place
- Fix the roof
- Clean the whole complex
- Clear the gutter along the road
- Repair the crocodile decoration outside

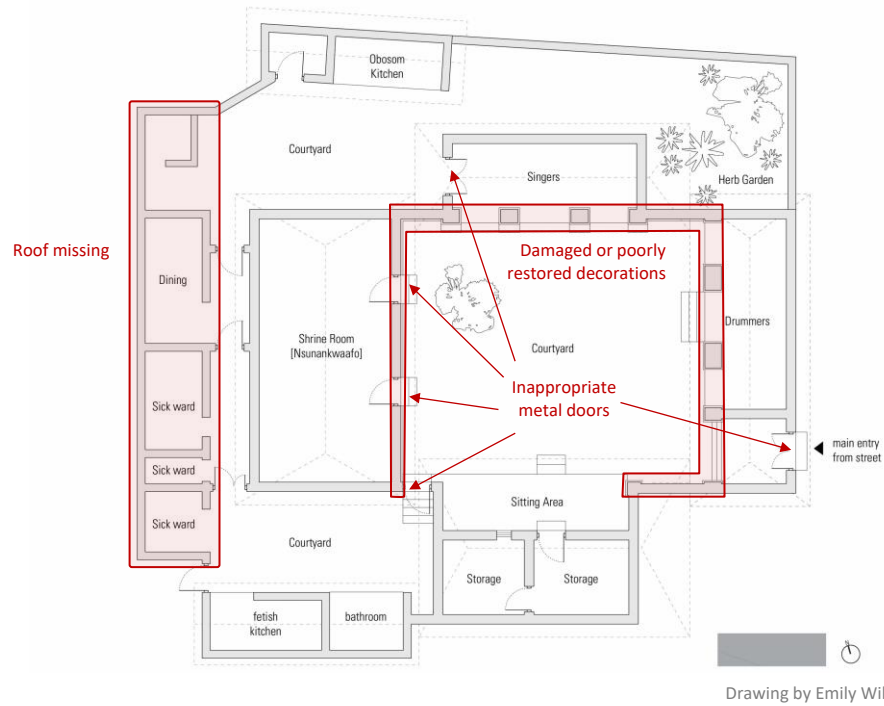
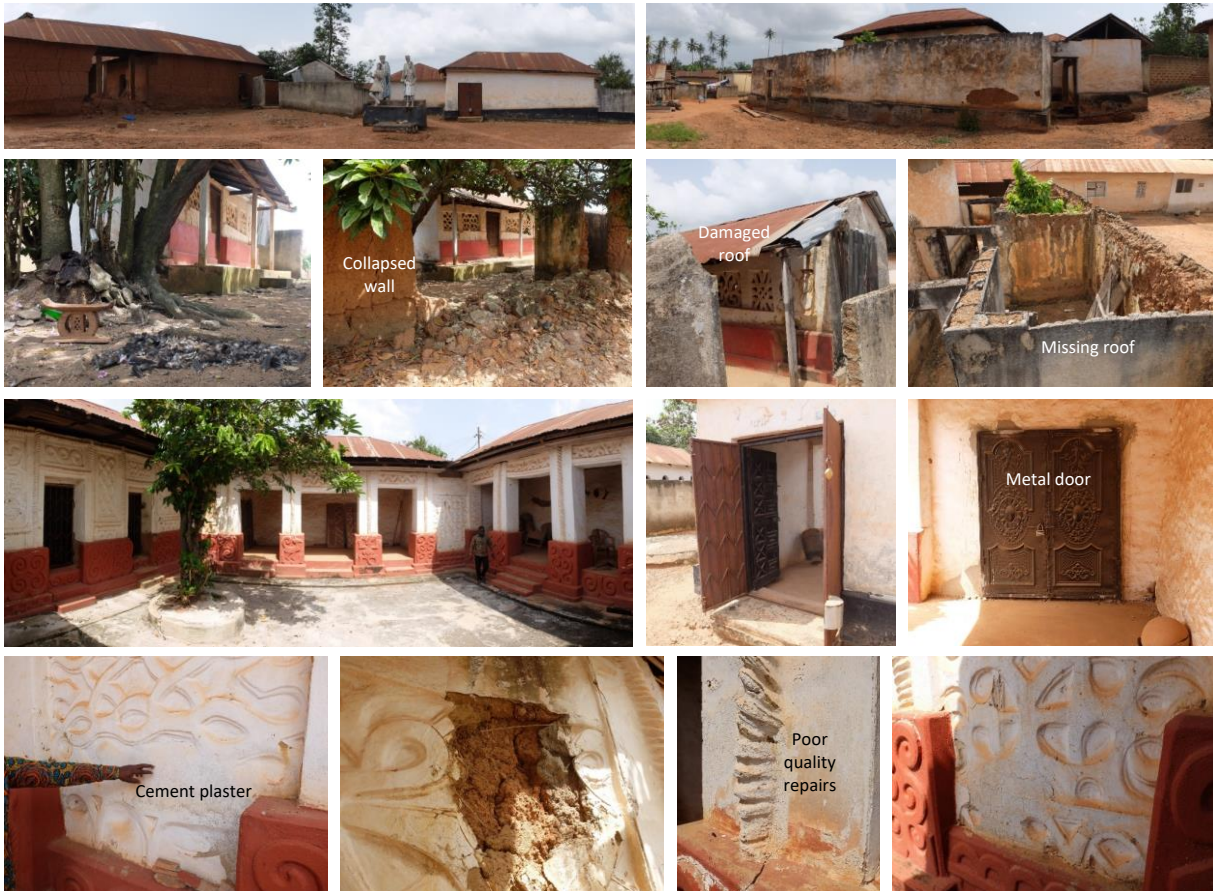
2.10. Patakro

This property consisting of several buildings (the shrine complex + two outbuildings) is in relatively poor condition. The roofs are badly damaged, some roofs are even completely missing (sick wards). Parts of the walls have also collapsed on the outbuildings.

In the main shrine building, the installation of metal doors and frames has led to the deliberate destruction of decorated wall sections. Many decorated surfaces were also damaged by roof leaks. Finally, a number of decorations have been reworked with cement plaster and white paint. This has led to beautifully decorated surfaces being replaced by flat ones.

Roofs in poor condition or missing, collapsed walls, inappropriate doors and damaged decorations...
but very strong spiritual life in this shrine.

- Replacement of the missing roofs
- Restoration of the decorated surfaces

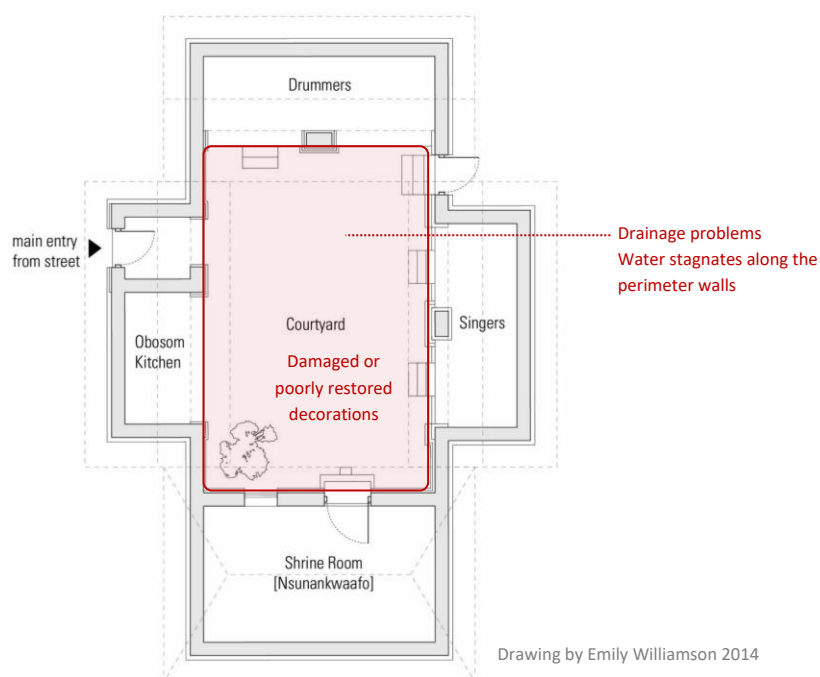
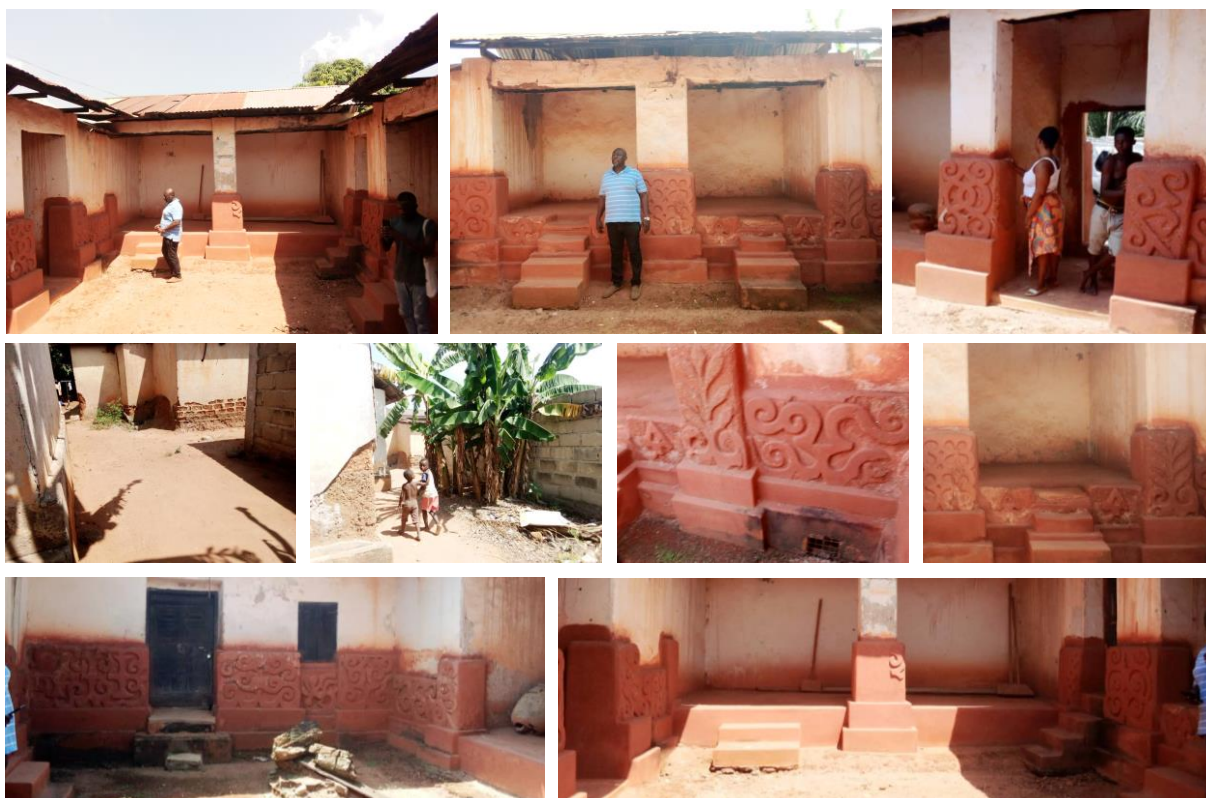
2.11. Saaman

The property is in poor condition, neglected and exposed to encroachment. It is not used for rituals and gives the impression of being isolated and lifeless. The courtyard is slightly bulging in the centre, causing water to flow and to stagnate along the walls. The peripheral drainage is on the other hand working well. The humidity is very present in the yard. The decorations are very damaged and missing in some places. The roof is also in very poor condition and leaking.

Damaged roofs, poor drainage and damaged decorations.

- Marking the site boundaries to avoid encroachment
- Replacing the roof

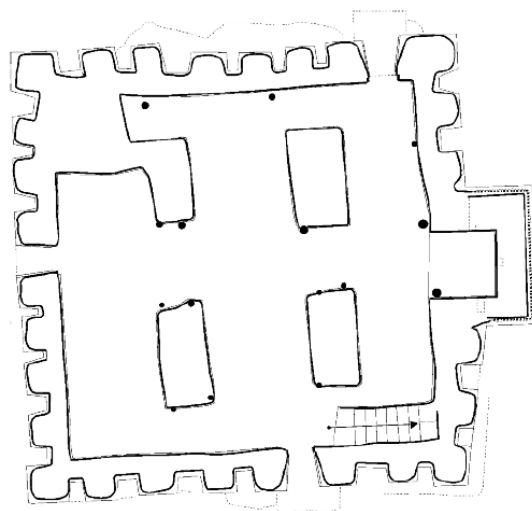
Damaged wooden sticks on all sides
Several cracks in the plaster

All surfaces including the surrounding ground are covered with thick waterproof layers.

- Protection of the site to avoid encroachment
- Sensitisation of the craftsmen and donors on adapted conservation techniques

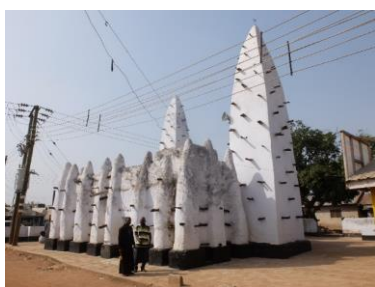
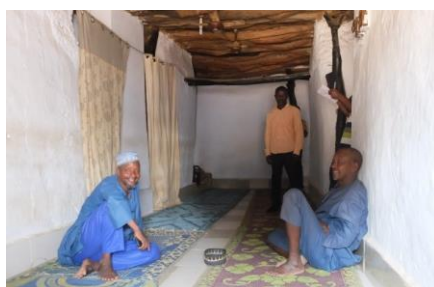
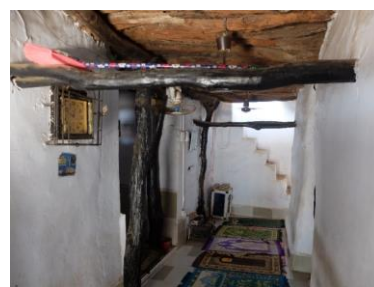
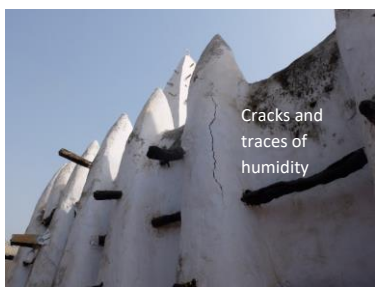
Cracks and traces of humidity

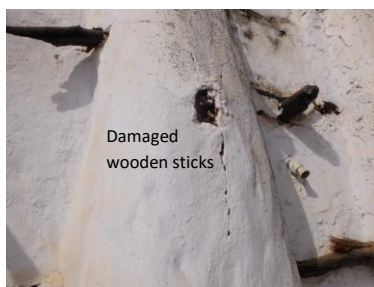
Damaged wooden sticks

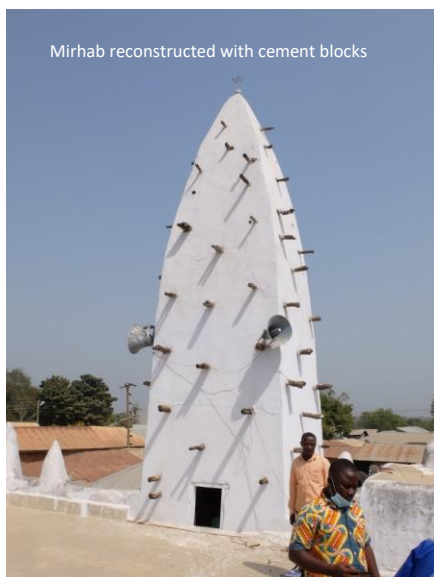
Mirhab reconstructed with cement blocks

Impressive and well-maintained mosque, although it is being modified. The interior has been tiled and the mirhab is no longer made of earth bricks but of cement blocks.

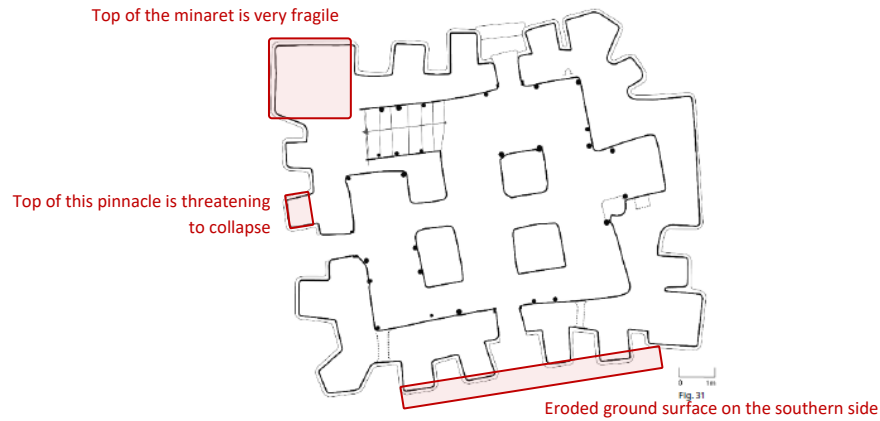
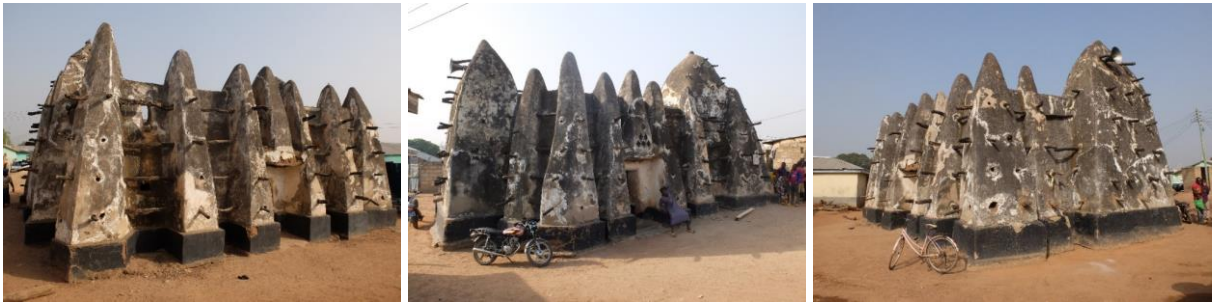
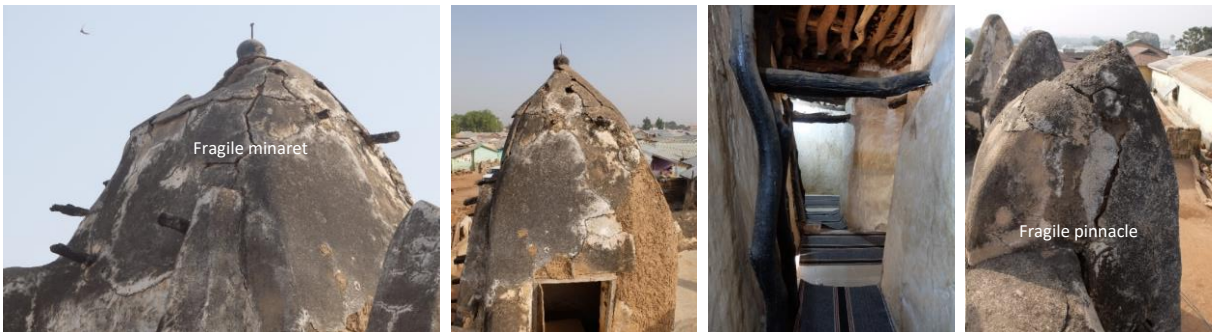
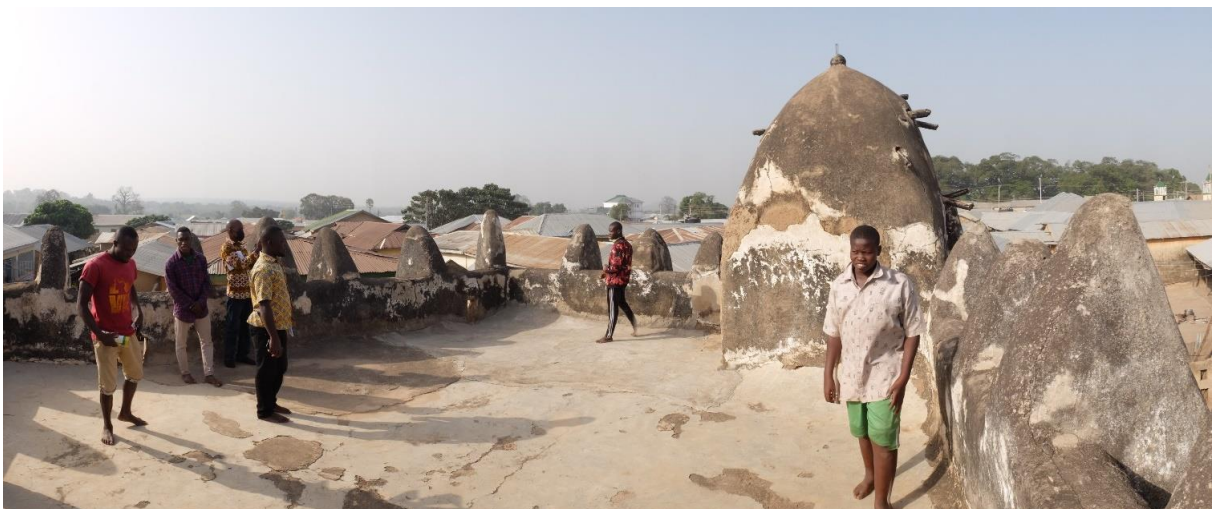
This mosque is covered with a thick shell of sand-cement plaster that suffocates it. The Chief Imam and his relatives know that it is not working and that the plaster is blackening, cracking, peeling and in need of constant replacement, but they persist in doing so because they have found no other alternative. The generous worshippers also give them bags of cement instead of money, which forces them to continue this "new tradition" that has been going on for more than thirty years. According to the imam, they also received a new loudspeaker and cement bags from GMMB in 2014.

This mosque continues to hold up despite the thick crust of cement that traps moisture in the walls, which display many pathologies. The chief imam and worshippers are taking care of it, but better plastering techniques are to be considered in the medium term.

- Urgently : remove plaster from the top of the minaret as well as from some pinnacles where it threatens to fall. Replace with stabilised soil mortar before repainting.
- Add soil on the southern side, especially where the roof water is dripping from the gargoyle
- On the long term : remove all the cement crust and replace with stabilised mortar.

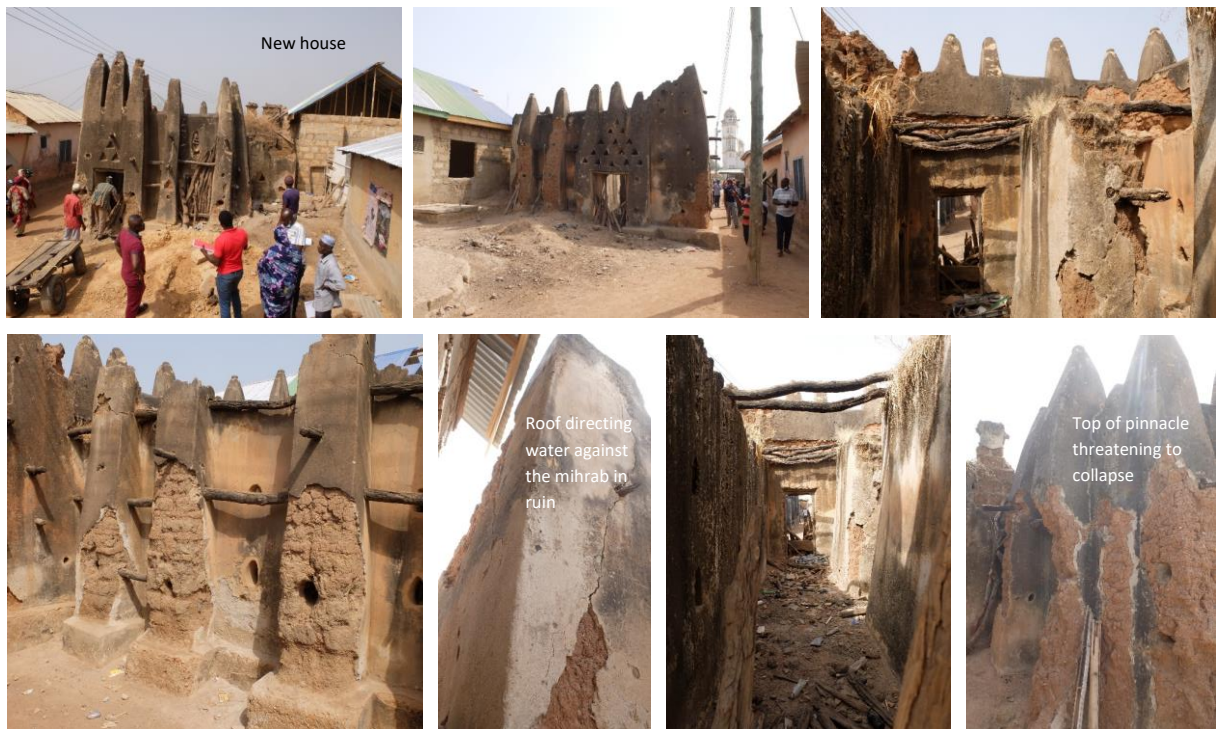
Although the roof collapsed in 2015, the envelope is almost intact, with most of the pinnacles in place. The damage is serious but there is still time to save this beautiful little mosque. The tops of the walls are damaged, none of the roof beams remain and the mirhab on the east side has no top. A new building is discharging its roof water against the remnants of the mirhab. If this new construction is not destroyed, major damage is expected during the next rainy season.

Remains of Dondoli mosque. The walls are almost intact but the roof is gone
